Revised Report of Reserve Study

NAPLES SQUARE II CONDOMINIUM ASSOCIATION

**1035 3rd Avenue South,
Naples, Collier County, Florida**

**SOCOTEC Project Number 4703-001.04
September 2022**

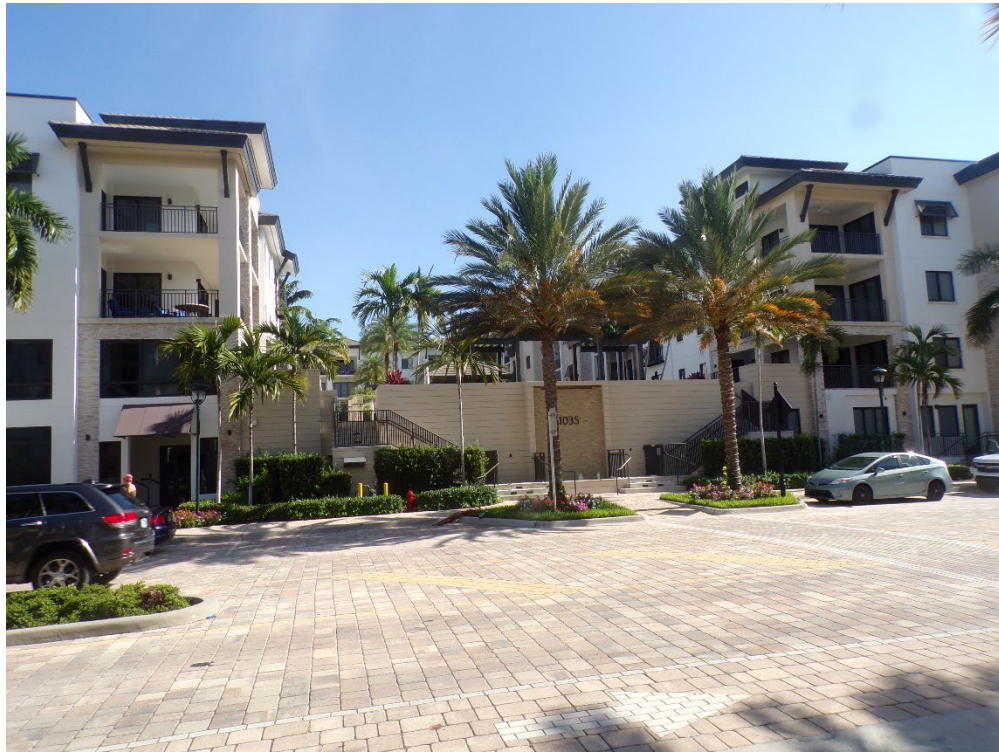
Overall view of Naples Square II Condominium.

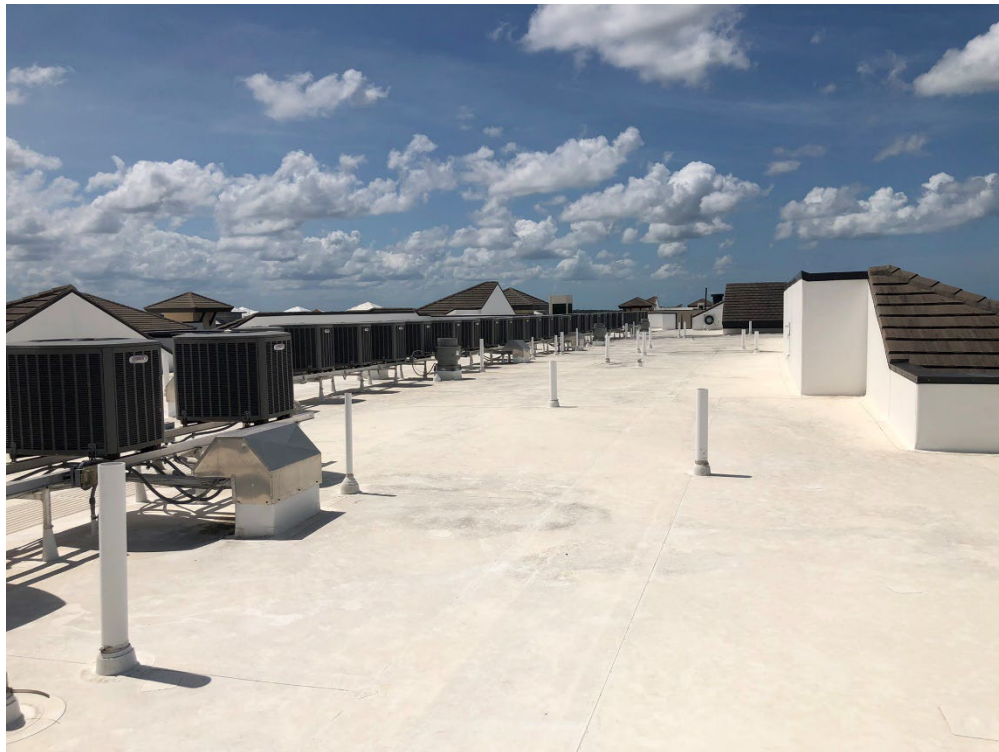
View of TPO flat roof membrane and typical metal HVAC stands.

Thermoplastic Polyolefin (TPO)—The flat roof system on the condominium building consists of a single-ply TPO membrane which typically has a useful life of up to 20 years under normal operating conditions. In total, the TPO system covers approximately 34,500 square feet of total roof area at the subject site and was installed in 2017. Assuming normal preventative maintenance, we anticipate that replacement will not be necessary until circa 2037.

HVAC Stands—The condominium also includes approximately 75 individual cooling HVAC units on the main roof that are elevated and supported by a set of metal beams that are anchored to the roof system. Our experience suggests that these stands are typically able to have useful lives of 40 years or more if regularly maintained. We anticipate these items could be scheduled for replacement circa 2057.

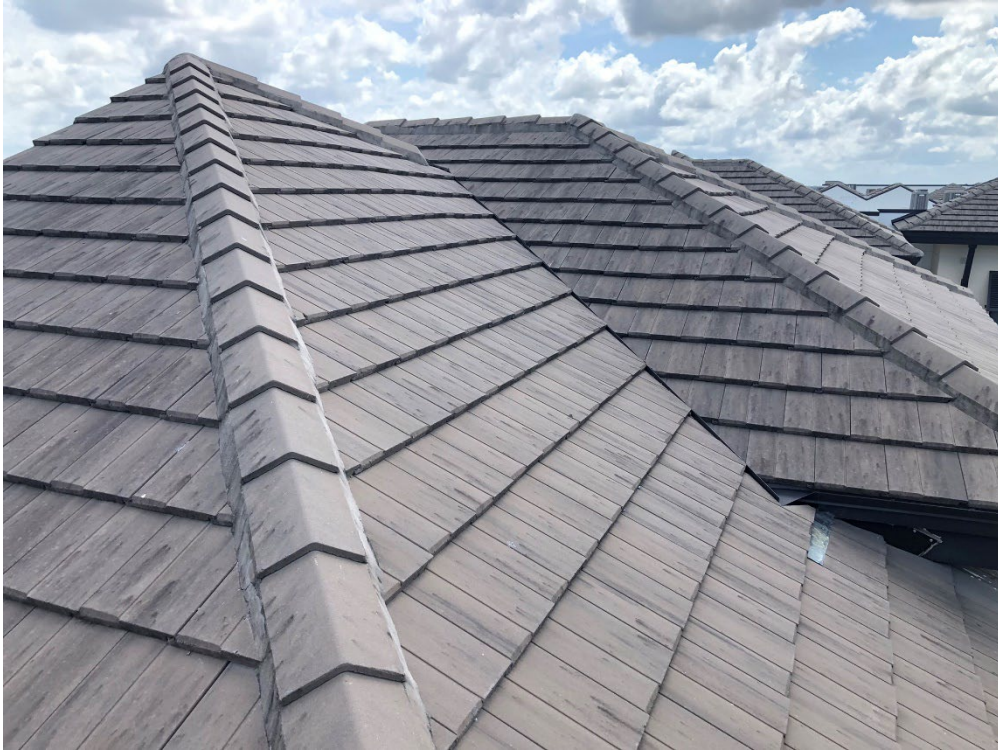
View of typical sloped, flat concrete roof tiles.

Concrete Roof Tiles—The sloped roof areas of the condominium building, and amenity level kitchenette structure are covered with approximately 31,200 and 550 square feet of flat concrete roof tiles, respectively. The concrete tiles and underlying waterproofing system are original components installed in 2017. Therefore, we recommend the Association schedule to replace all of the Association roofs circa 2042 based on a typical 25-year.

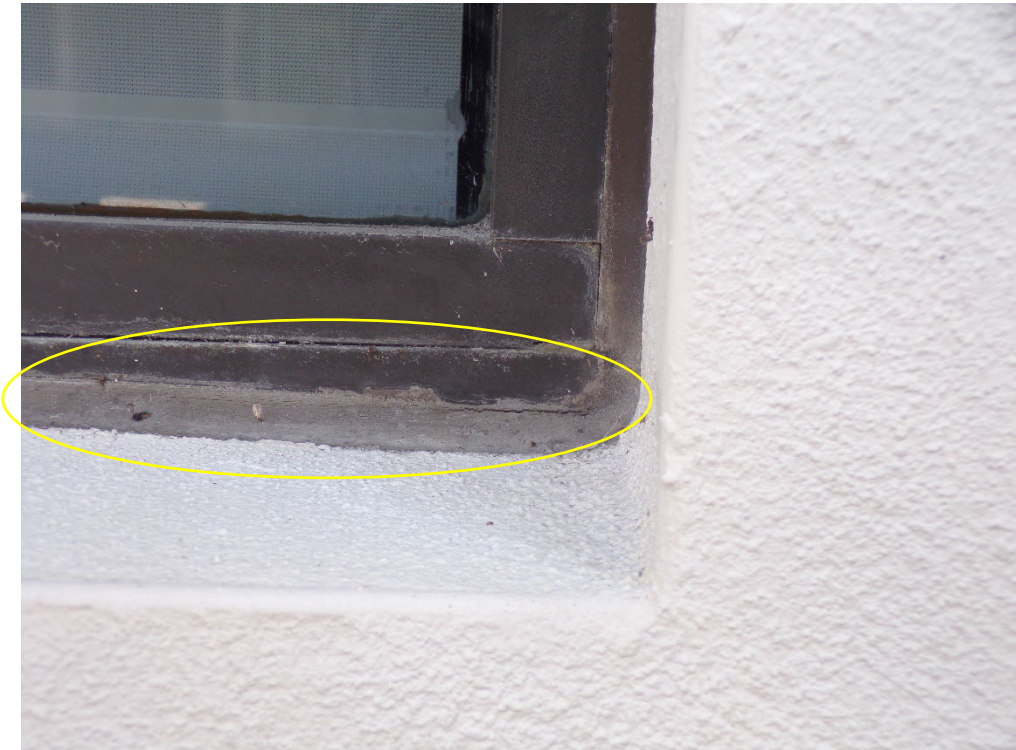
View of failing window sealant.

Exterior Windows & Doors—We understand the Association is responsible for the replacement of all condominium windows and common area doors. We also understand all windows and doors located at the subject site are original. With a typical useful life of 30 years, we anticipate the condominium windows and doors will require replacement circa 2047.

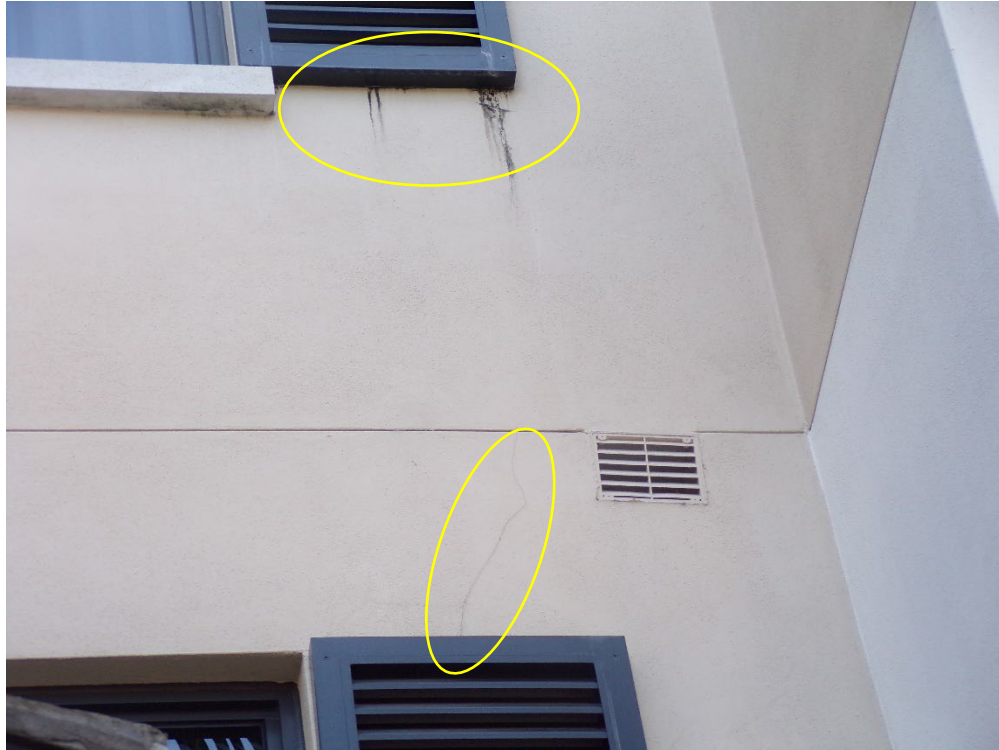
View of cracking stucco and staining from windowsill.

Exterior Paint—The Association is responsible for maintaining, repairing, and recoating the exteriors of the condominium, metal railings, aluminum frames, and cleaning and sealing all exterior joints, fasteners, and other components. We understand the Association was originally coated in 2017 following the original construction of the building. The existing paint was observed to be in fair overall condition. For buildings located near the Gulf of Mexico in the Southwest Florida region, we recommend the exteriors be recoated on a 7-year basis following a recoating 5 years after original

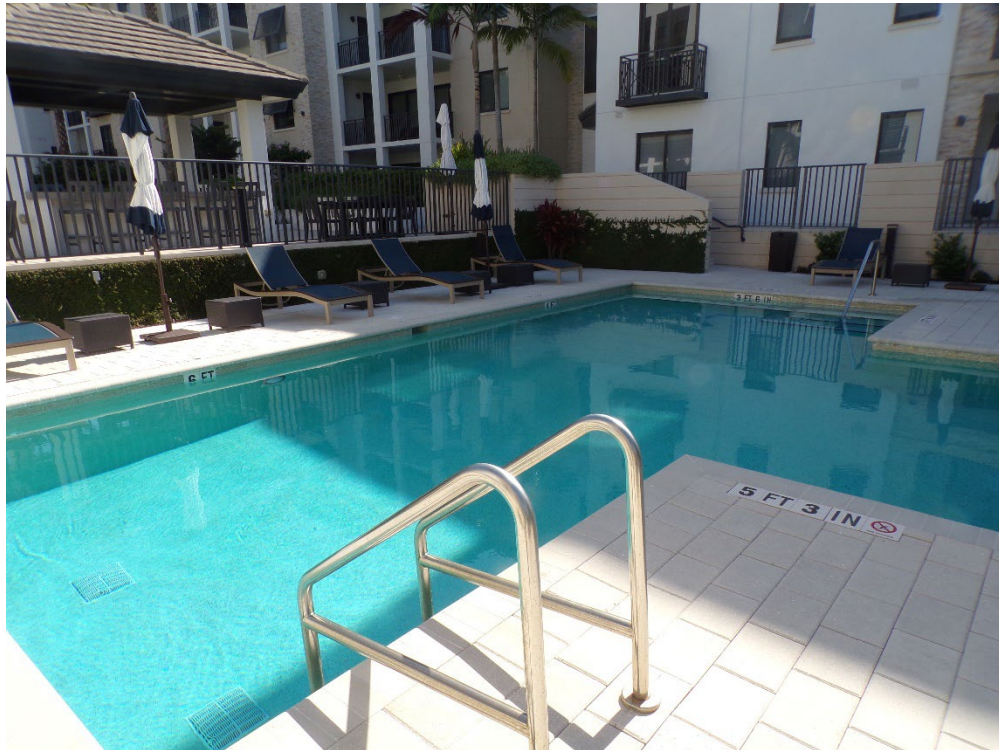
Overall view of pool deck and associated furniture.

Pool Deck Concrete Pavers—The pool decks located at the subject property are surfaced with approximately 2,500 square feet of decorative concrete pavers. Pool deck pavers typically experience an accelerated weathering process since they tend to be exposed to more water and other chemical elements. Therefore, we recommend the pool deck pavers be scheduled for replacement circa 2047 based on an approximate 30-year useful life.

Pool Furniture—Exterior furniture experiences heavy wear-and-tear and should typically be replaced on a 10- to 15-year basis, or as desired. This line item includes the tables, chairs, and grills located around the pool deck. We understand the Association currently replaces their pool furniture on an approximate 5-year schedule and the furniture was scheduled to be replaced accordingly in 2022.

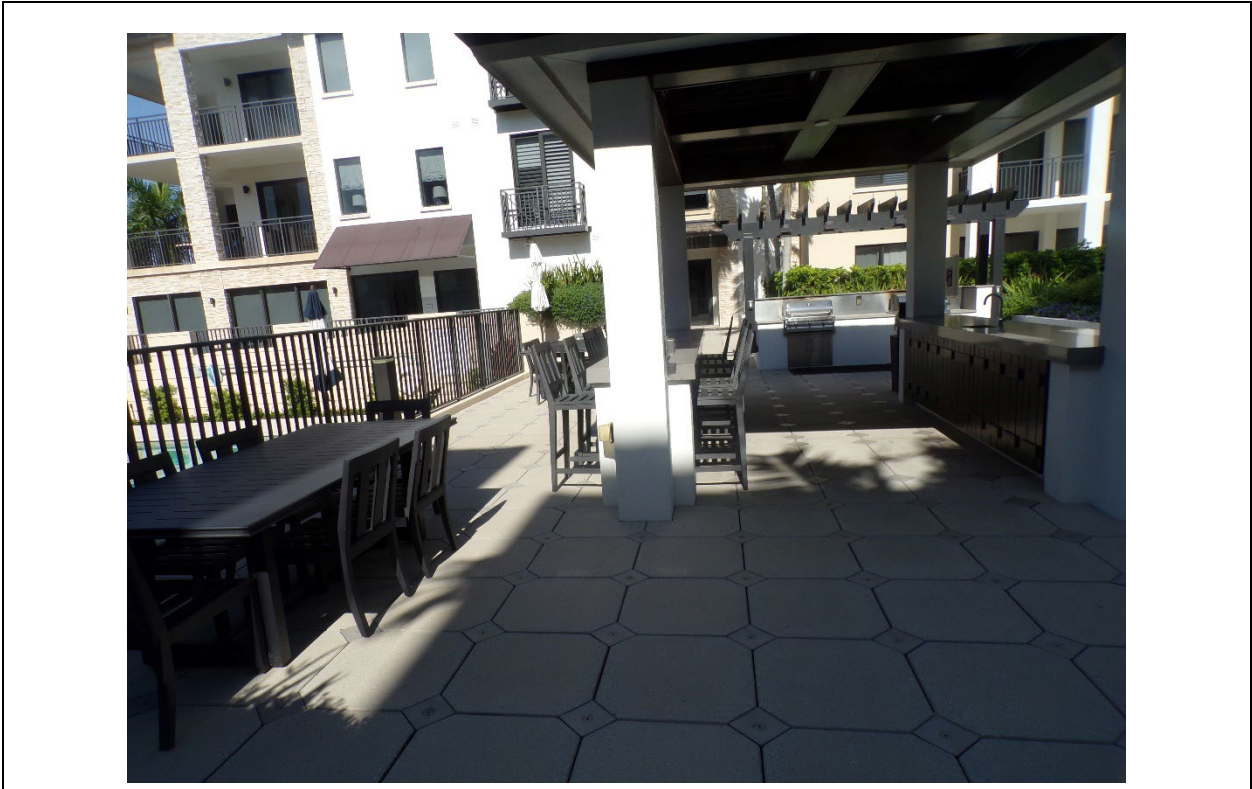
Overall view of outdoor kitchen area.

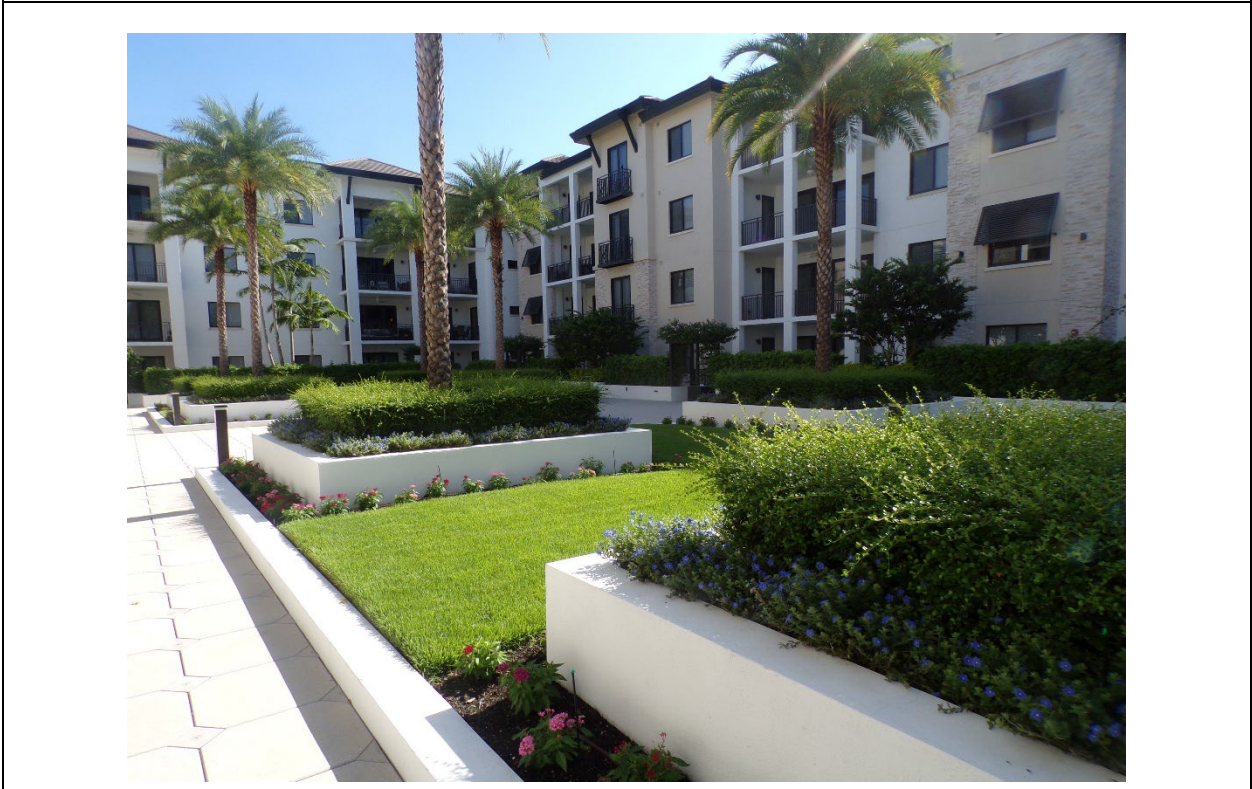
Overall view of courtyard area.

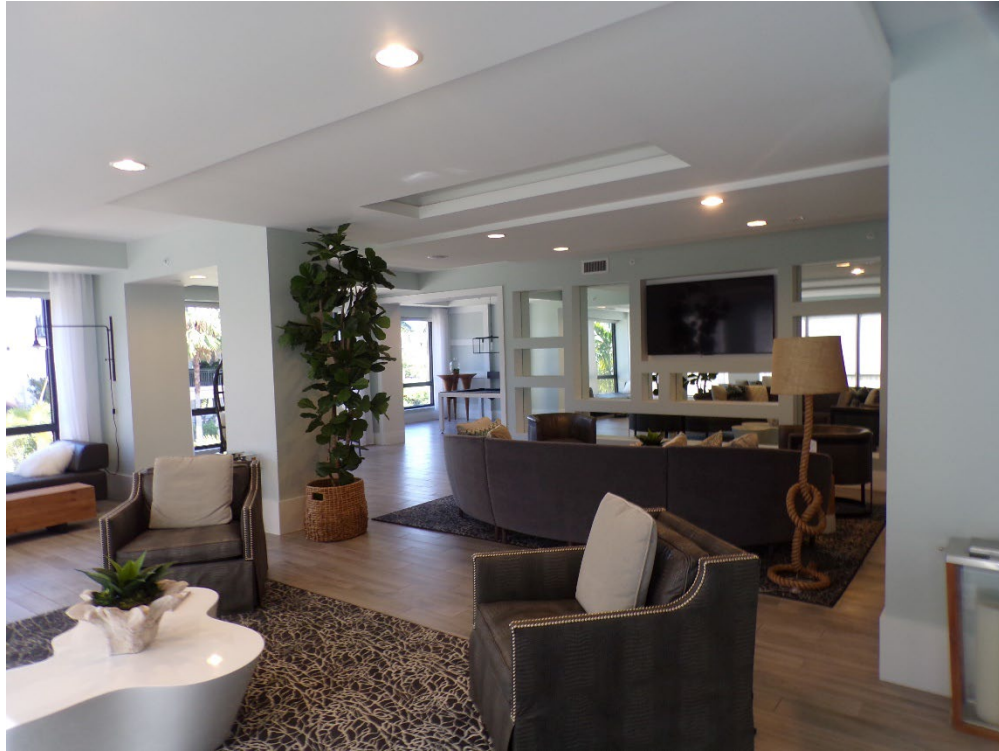
Overall view of clubhouse interior.

Interior Furniture & Renovations—This section of the reserve study includes the furniture and interior renovations for the condominium lobbies, social rooms, bathrooms, pool bathrooms, and elevator interiors. This category includes, but is not limited to, furnishings, wall finishes, decorative tile- or vinyl-covered areas, light fixtures, tables, chairs, bathroom and elevator renovations, and other associated items. Although miscellaneous replacements are required periodically, the useful lifespan of common area furniture (chairs, tables, etc.) are expected to be about 10 to 15 years, whereas complete renovations could be completed on a 15- to 20-year schedule. Based on the condominium's original construction in 2017, we have generated several reserve budget line items to help the Association cover future interior renovation and furniture expenses. However, the budget and replacement frequency of these elements is greatly dependent on the Association's wishes.

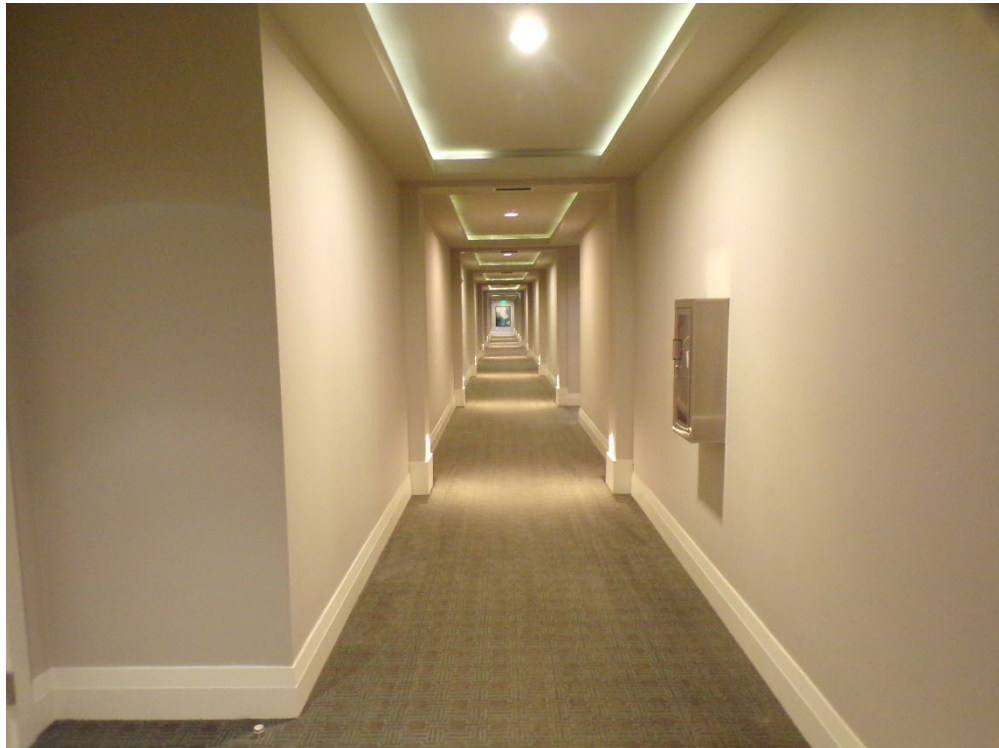
Overall view of typical common area hallway.

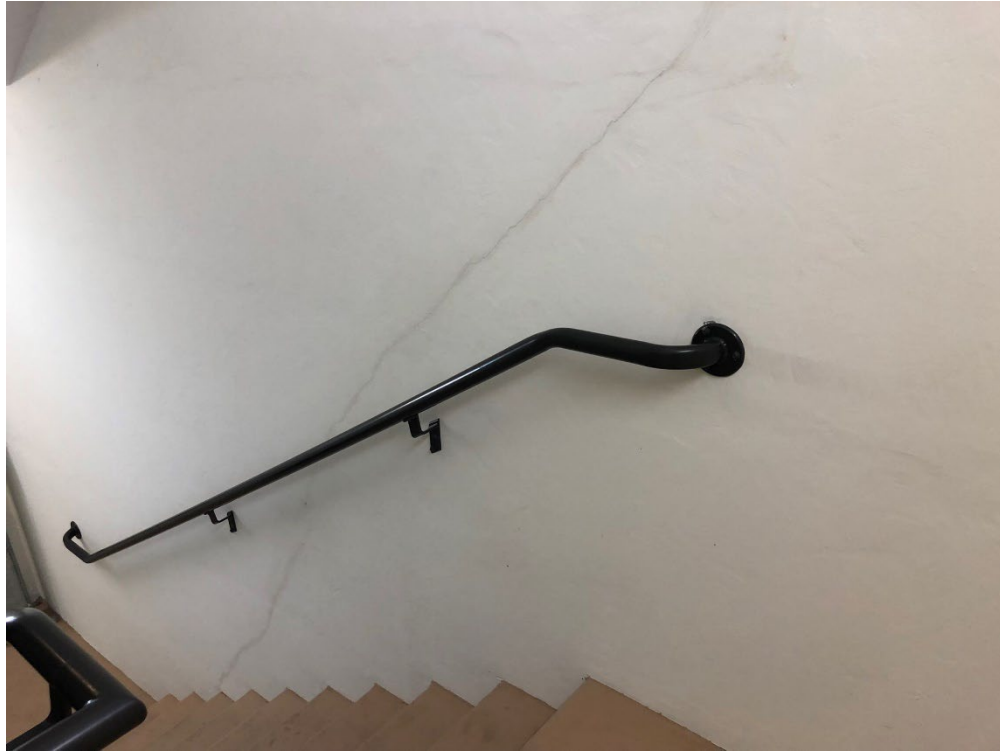
View of concrete cracking inside stairwell.

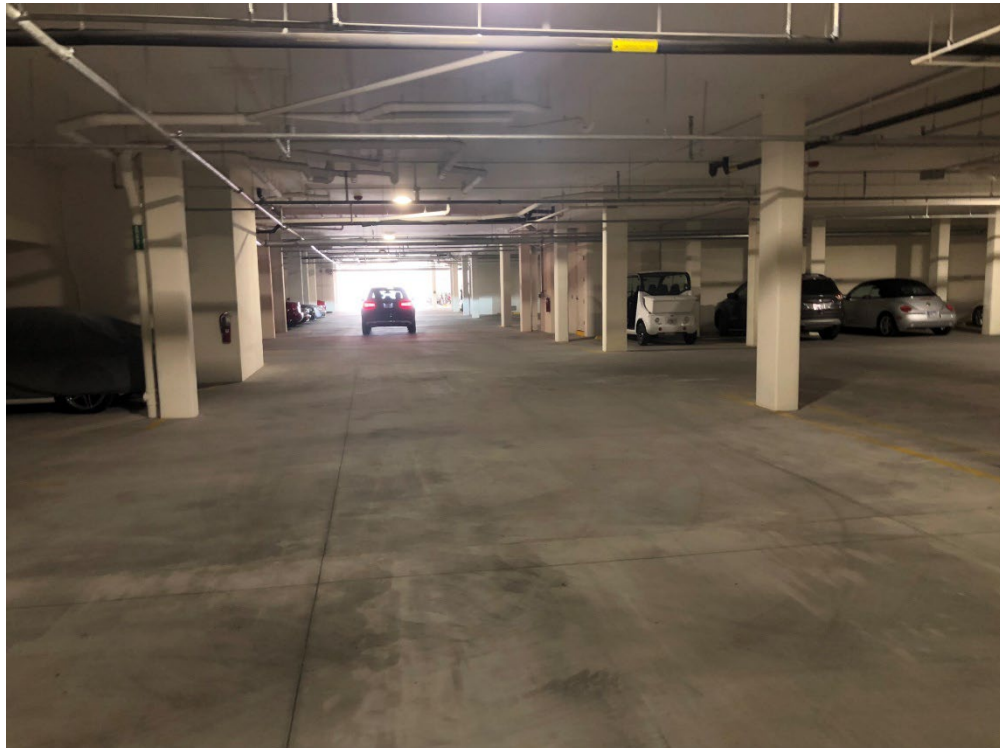
Overall view of garage interior.

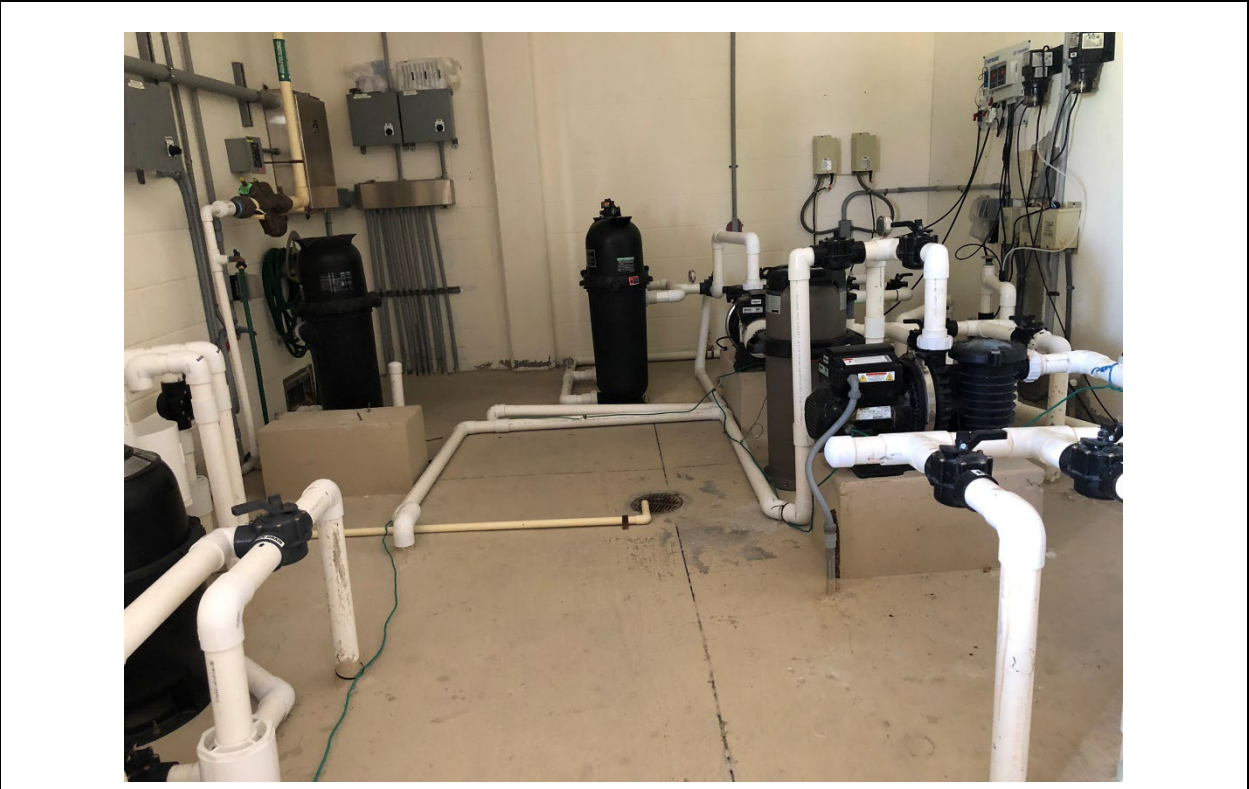
Overall view of pool equipment room.

Heaters & Equipment—The pool/spa heaters and the supporting equipment for the pool, spa, and fountain feature are located in mechanical rooms located below the pool deck. The equipment consists of two 1-horsepower pumps, two 2-horsepower pumps, one 3-horsepower pump, four filter systems, two gas heat pumps, and other chemical treatment systems. Based on our experience, pumps have a shorter life expectancy than pool heaters. Pool pumps and equipment have a typical useful life of 8 to 15 years, whereas heaters should be replaced approximately every 8 to 10 years. Because pool equipment is typically only replaced on an as needed basis, we have allocated an annual budget of \$3,000 to fund the replacement of any pool, spa, or water feature hardware. We anticipate the heaters will require replacement circa 2025 based on a typical 8-year useful life.

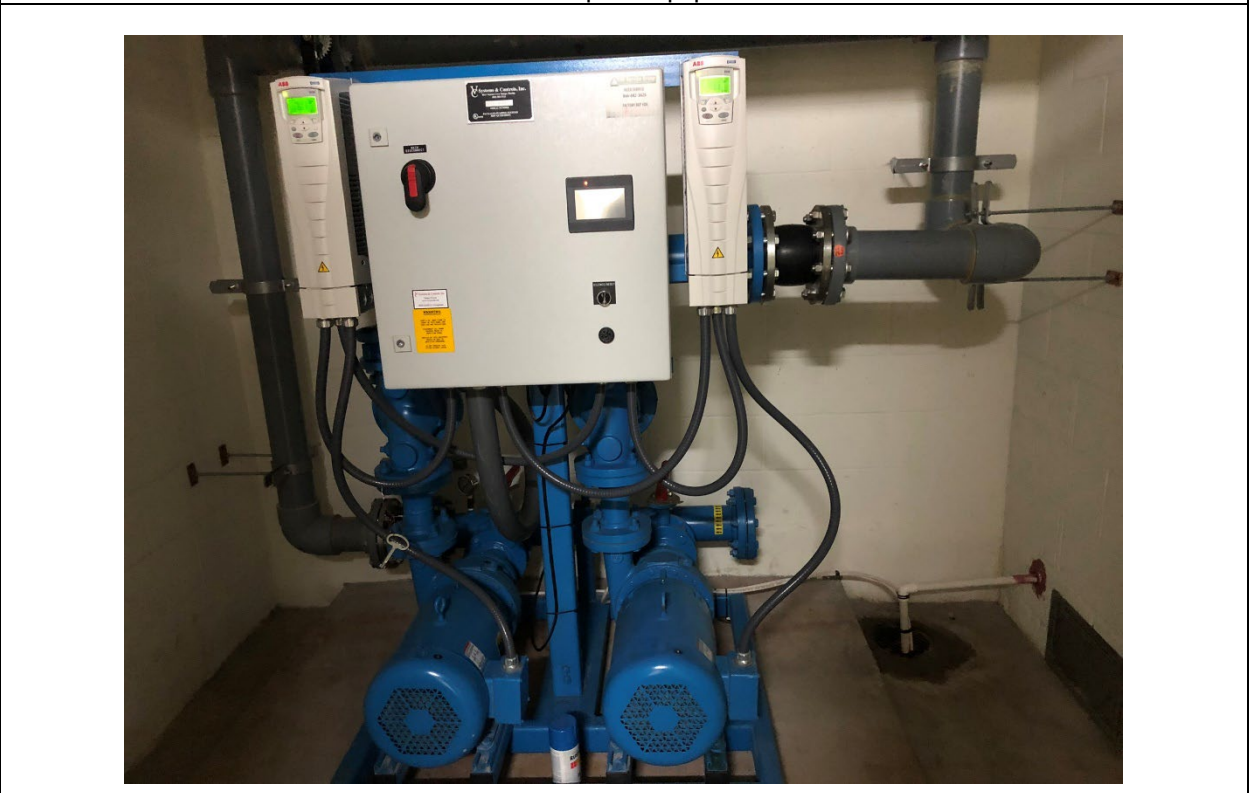
Overall view of domestic water pumps.

Domestic Water Pumps and Controls—The domestic water pumps and control system for the condominium are located in a mechanical room located on the ground floor in the southwest corner of the parking garage. With useful lifespans between 8 and 15 years for pumps, they should be anticipated to be replaced circa 2025. Pump controls have a typical useful life in the vicinity of 24 years and should therefore be scheduled for modernization circa 2041. This element includes two 10-horsepower pumps and a control panel system.

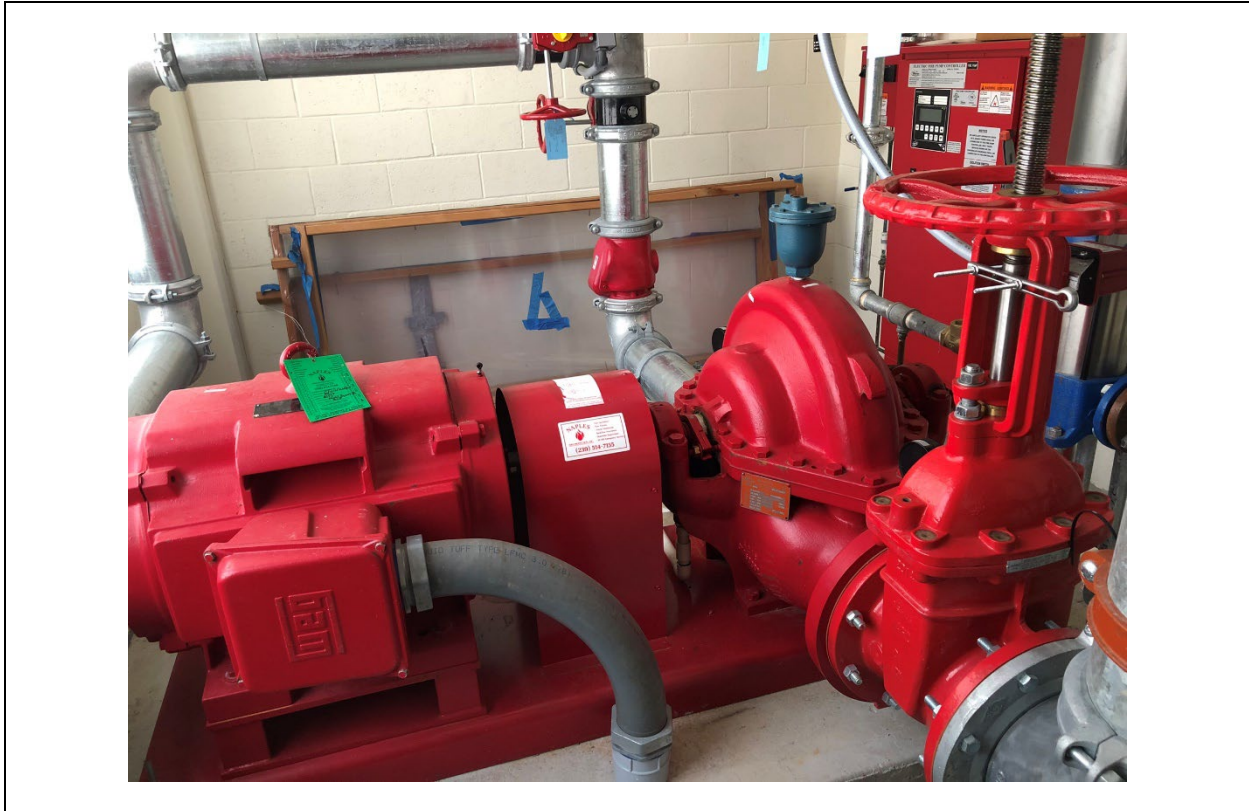
Overall view of fire pump.

Fire Pump and Controls—The fire pump and its respective control panel are located in a mechanical room located along the south end of the parking garage on the ground level. We understand the fire pump and control panel are original components. With typical useful lives of 25 years for pump controls and 40 years for the fire pump, we anticipate these items will require replacement circa 2040 and 2055, respectively. However, these items are typically replaced in tandem to ensure product compatibility. Therefore, we estimate a 30-year useful life for both components and anticipate they will be replaced circa 2047.

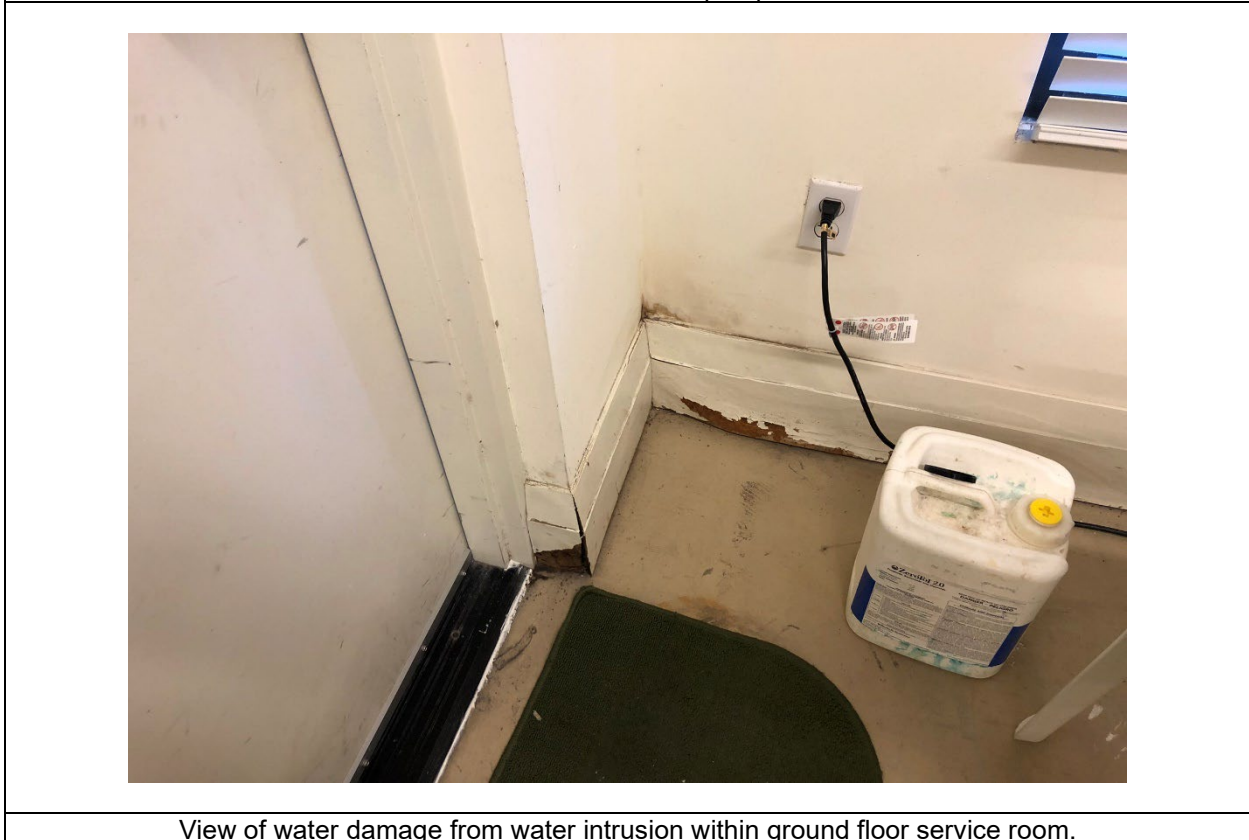
View of water damage from water intrusion within ground floor service room.
